Expert Report of Sheldon V. Masters, Ph.D.
(Bellwether 3)

In Re Flint Water Cases,
U.S. District Court for the Eastern District of Michigan
Civil Action No. 5:16-cv-10444-JEL-MKM
(coordinated docket)

Walters, et al. v. Snyder, et al., Civil Action No. 5:17-cv-10164-JEL-MKM
“Bellwether 3 Trial”

4 VISUAL INSPECTION OF PIPE SAMPLES FROM FLINT HOMES

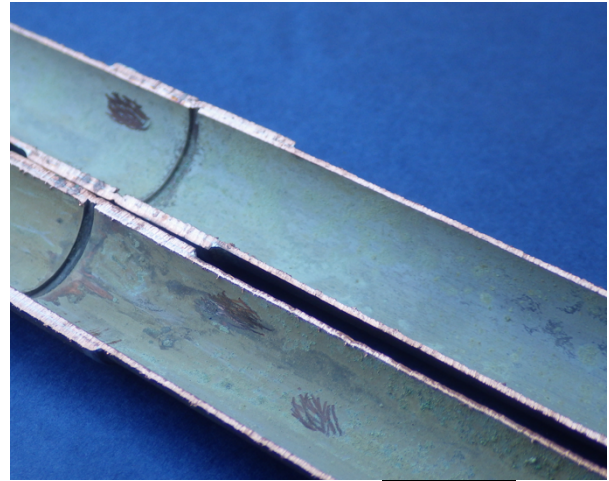
[REDACTED] were supplemental report by the plaintiffs' expert (Russell, 2022). The pipes were removed from the homes in February 2022 and included copper and galvanized iron pipes and brass fittings. In general, the copper pipes from both homes were in good condition with no apparent pipe thinning or pitting. Most of the copper pipes that were cut longitudinally had a thin blue-green scale layer which is consistent with the appearance of malachite scales (Arnold Jr. et al., 2012). Sample B from [REDACTED] had inconsistent scratches which a [REDACTED] from a sharp tool (Figure 20).

Figure 20. Sample B from [REDACTED]

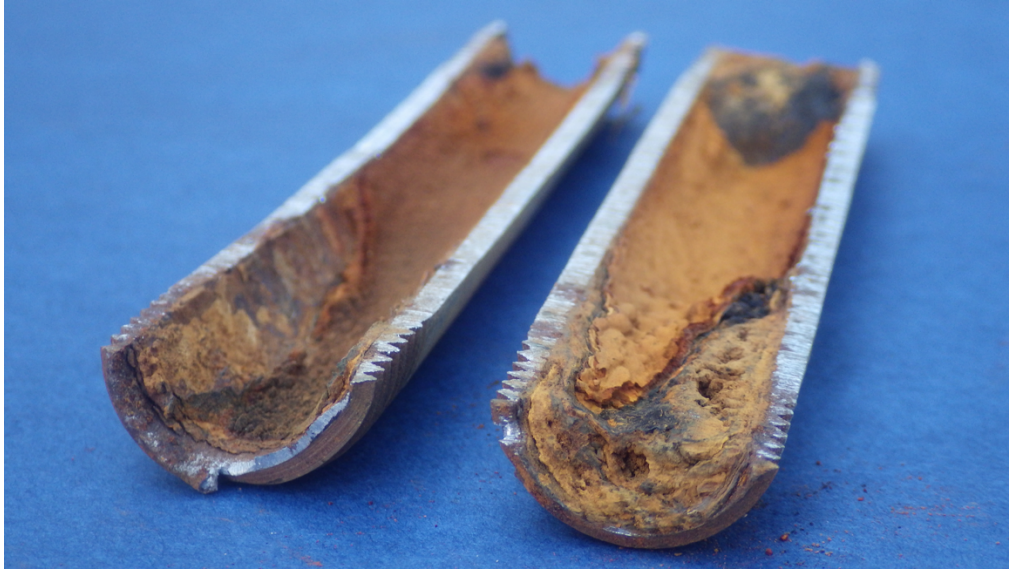
Most sections of the galvanized iron pipes from both homes were heavily tuberculated which is typical of galvanized iron pipes that have been in service for more than half a century (Edwards et al., 2022). An example of this is shown in Figure 21. Similar kinds of tuberculation can be seen in Figure 22 which shows the cross section of galvanized iron pipe from a Midwest surface water supply that has used blended phosphate for more than 20 years (Wasserstrom et al., 2017). Between 1999 and 2010, this system also had an average lead 90th percentile of 6 ppb (Del Toral et al., 2013).

For the vast majority of galvanized iron pipe sections there was no apparent thinning of the walls. However, wall thinning and failure was apparent at threaded sections. Failure at pipe threads typically occurs because cutting the threads during the manufacturing process removes the galvanized iron coating. Wearing can also increase significantly when streamlines are curved (e.g., at elbows) which results in centrifugal acceleration (Roy, 2018). For example, Figure 23 shows an elbow from a home in Cincinnati, OH where the wall has been penetrated likely due to this phenomenon. However, this kind of wearing was not apparent at of the elbows taken from the two Flint homes. Sample G (galvanized pipe a tee) and Sample H (galvanized iron pipe) from [REDACTED] both had through-wall pits which were likely caused by deposition [REDACTED] the upstream copper pipe. In both of these cases the pits appear to be sealed due to autogenous repair (Tang et al., 2015). Overall, for the age of the pipe specimens that I examined, there did not appear to be significant pipe wall thinning or pitting. Furthermore, most of the corrosion associated with these pipes and fittings occurred prior to 2014.

Figure 21. Galvanized iron Sample D from [REDACTED]

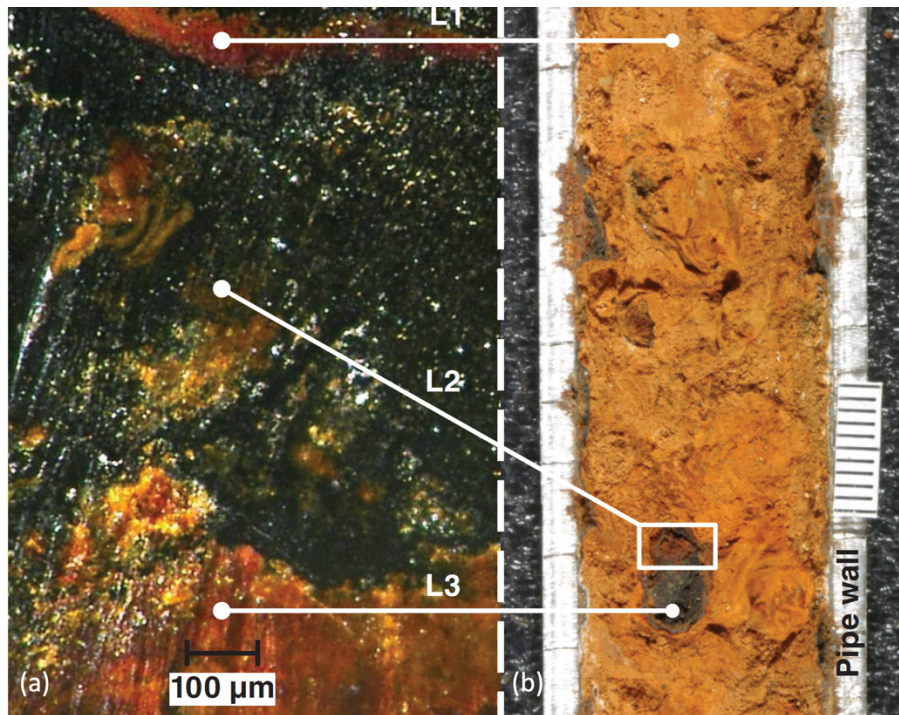
Figure 22. Cross sectional image depicts a) macro-scale image and b) the in-situ scale from a large midwestern city with optimized corrosion control. Image modified from Wasserstrom et al. (2017).

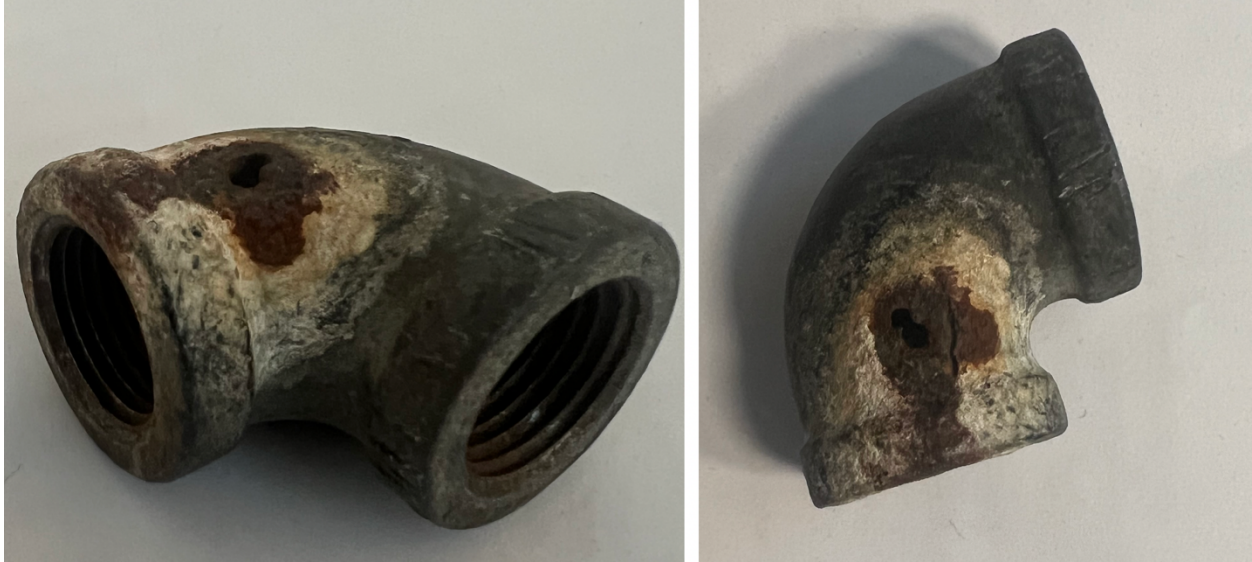
Figure 23. Galvanized iron elbow harvested from home in Cincinnati, OH.
